ACCIDENT RECONSTRUCTION REPORT

NCTI File Number: NC061218

March 25, 2020

Case Re: Jeremy Farris v. Brian Dana Jefferson, Michael Bishop, and National
Liability and Fire Insurance Company
US District Court, Western District of Louisiana, Lafayette Division
Civil Action No. 6:19-cv-108
Date of Accident: June 12, 2018
NCTI File: NC061218

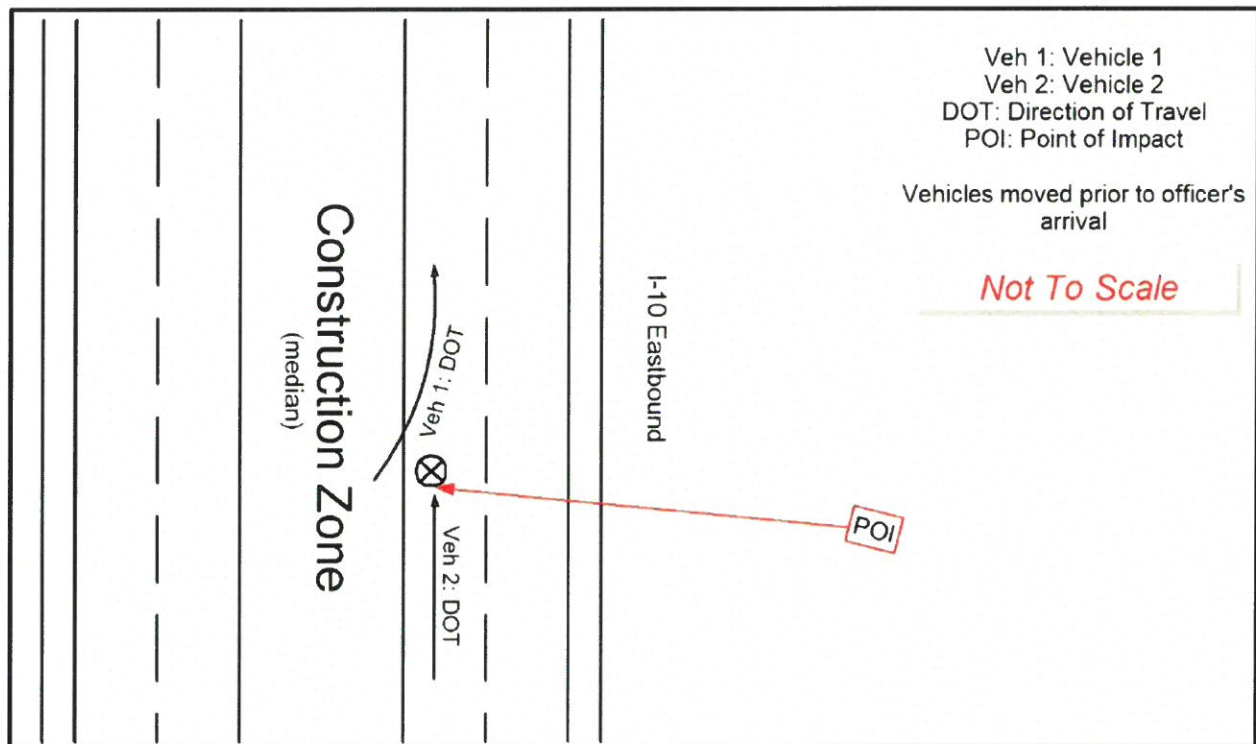
Figure 3: Police Report Diagram

Officer Landry's report included a Not-To-Scale diagram. See Figure 3.

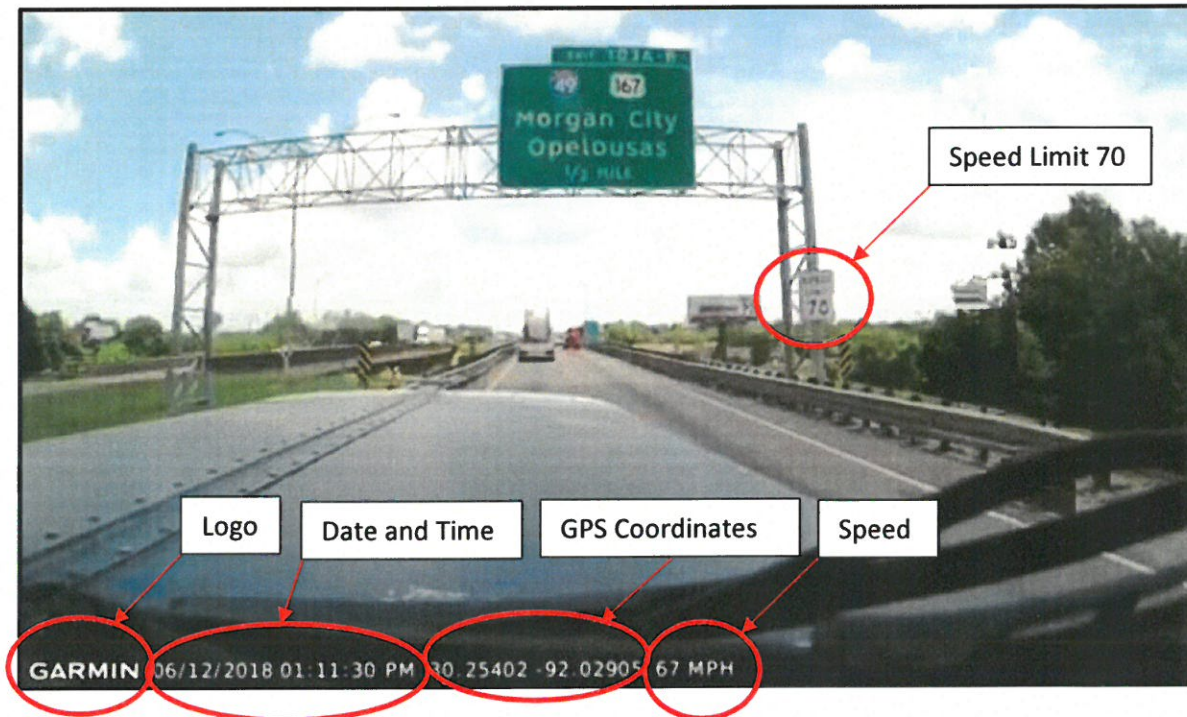
Figure 11:
Speed = 67mph

The video starts with Mr. Jefferson traveling 67mph in the left lane of I-10 East while passing signs for Exit 103A-B, I-49 and US Hwy 167 to Morgan City and Opelousas. As he continues east bound, Mr. Jefferson passes numerous construction warning signs, consistent with the LA DOTD plans. See Figures 11 through 22.

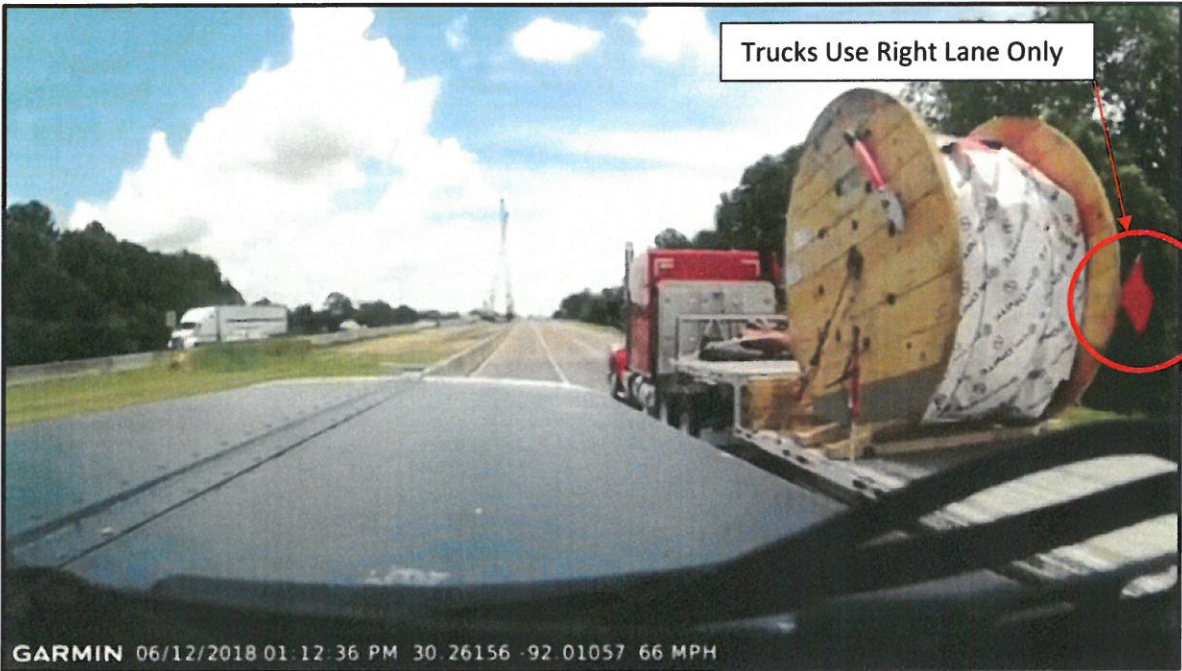
Figure 20:
Speed = 66mph

At 1:12 PM, about one minute before the accident, Mr. Jefferson passes a sign restricting trucks to use the right lane only.

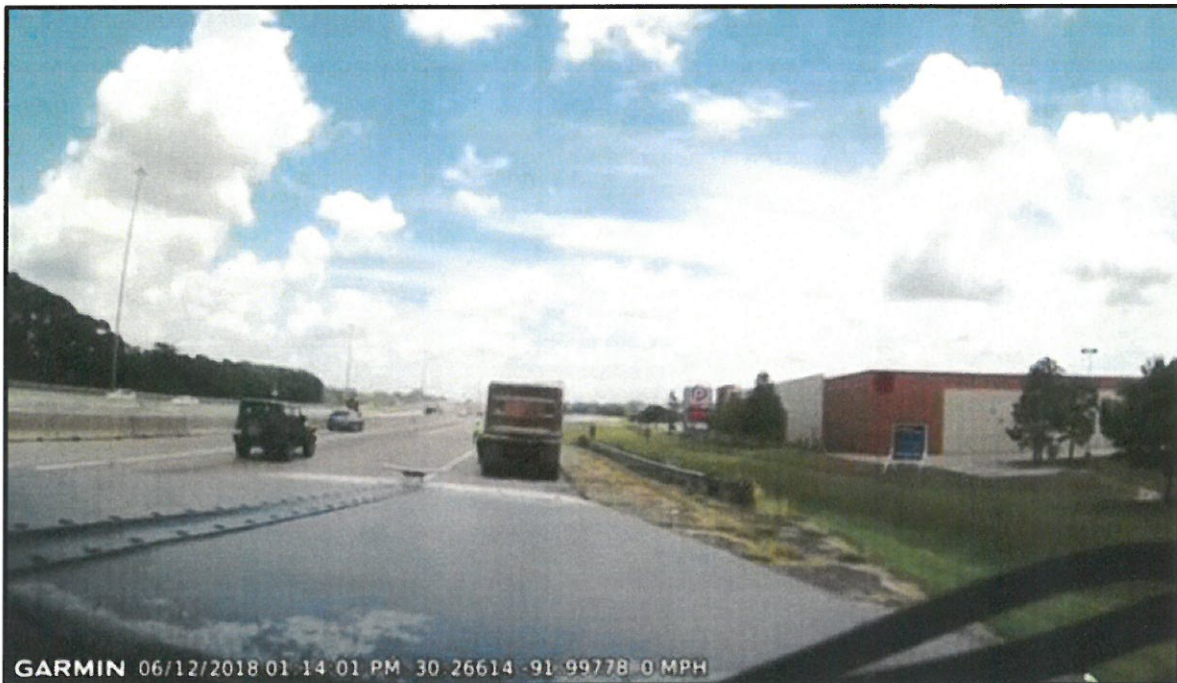
Figure 27:
Vehicles at Rest after Impact

Shortly after impact, Mr. Jefferson and Mr. Farris bring their vehicles to a stop on the right shoulder of I-10 East. See Figure 27.
